TEST REPORT No. 5845/17

TEST REPORT No. 5844/17

TEST REPORT No. 5843/17

**Evaluating Ceramic Floor Tile Installation Systems Using
the Robinson-Type Floor Tester**

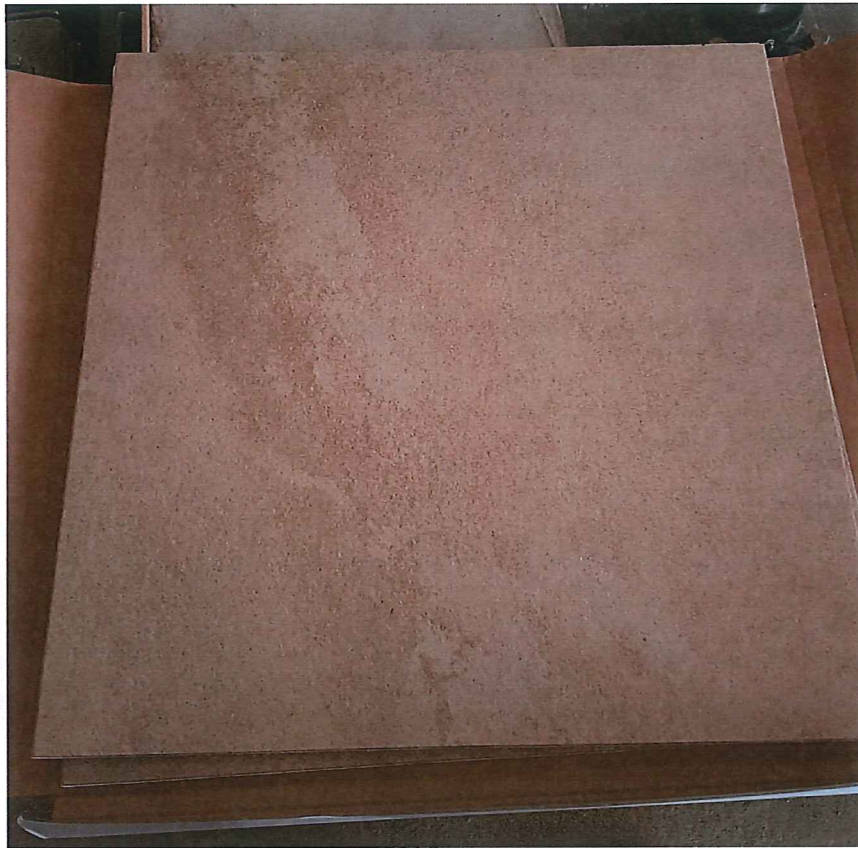
Photo 1 – Front of the element: work surface

Multilayer elements for flooring of size 60x60x1 cm marked "GRES PORCELLANATO - GRUPPO B1a SECONDO EN 14411:2016 - AUTOPOSANTE MAGNETICO BREVETTO BASSI GROUP INTERNATIONAL", see photo1 and photo 2.

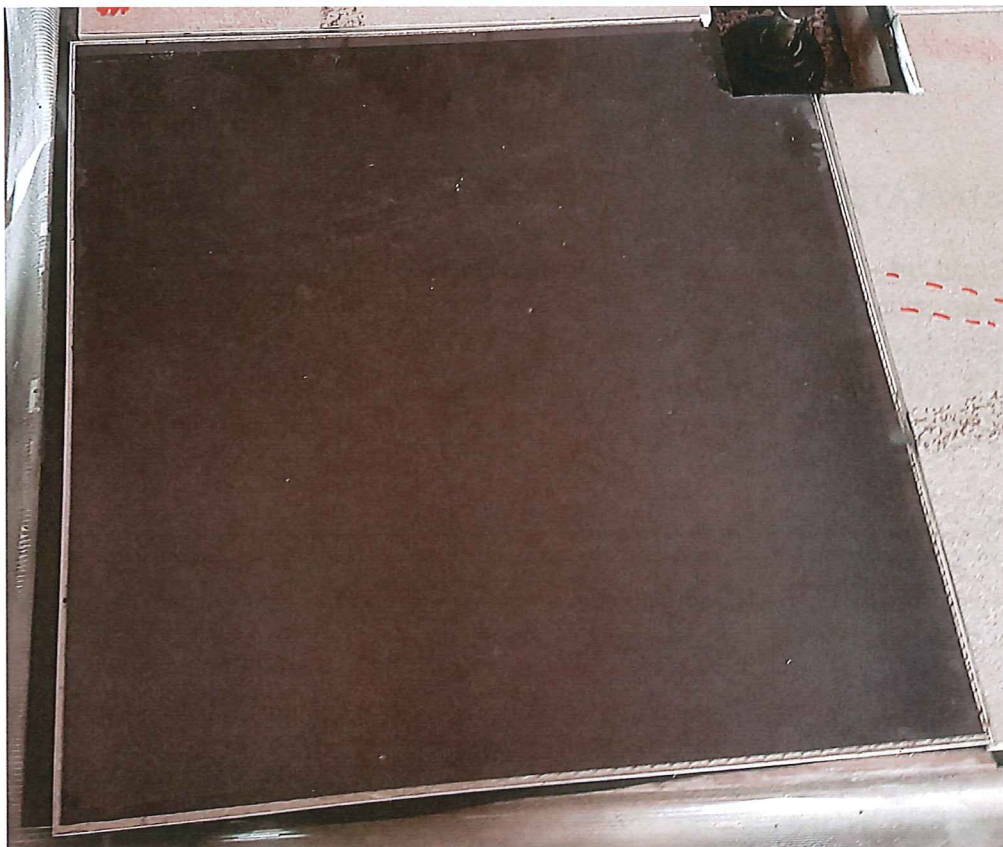
Photo 2 – Back of the element

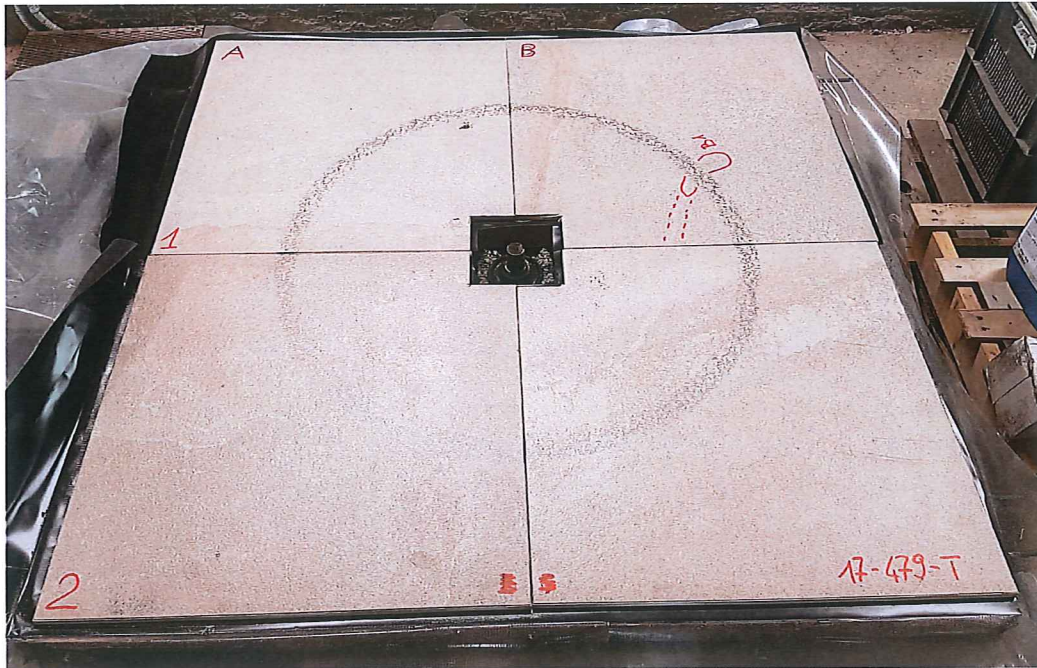
Photo 3 – Full assembly after testing

Cycle Type of Wheels	Type of Wheels	Total Weight per Wheel lbs (kg)	Duration of Test, h	Total Number of Revolutions	Damage	N° of damage	Type of damage
1	Soft rubber	100 (45)	1	900	No damage	---	
2	Soft rubber	200 (91)	1	900	No damage	---	
3	Soft rubber	300 (136)	1	900	No damage	---	
4	Soft rubber	300 (136)	1	900	No damage	---	
5	Hard rubber	100 (45)	1	900	No damage	---	
6	Hard rubber	200 (91)	1	900	No damage	---	
7	Hard rubber	300 (136)	1	900	No damage	---	
8	Hard rubber	300 (136)	1	900	No damage	---	
9	steel	50 (23)	1/2	450	No damage	---	
10	steel	100 (45)	1/2	450	No damage	---	
11	steel	150 (68)	1/2	450	No damage	---	
12	steel	200 (91)	1/2	450	No damage	---	
13	steel	250 (114)	1/2	450	Damage	1	chipped and broken element
14	steel	300 (136)	1/2	150	No damage	---

Number of test cycles performed	13
Highest number of the test cycle the installation passed	13

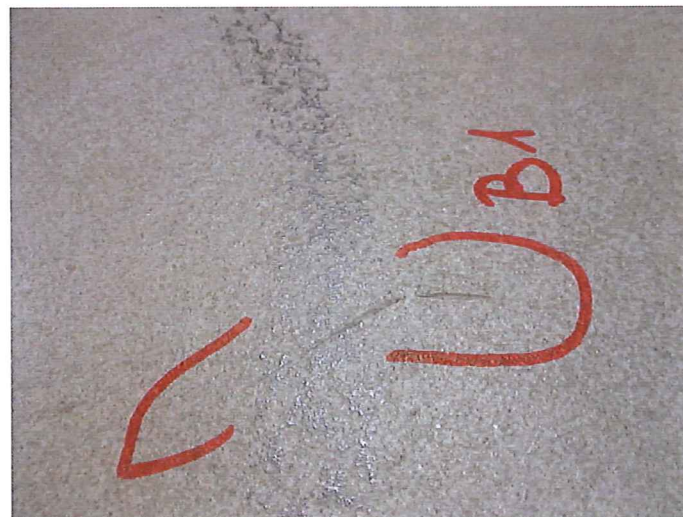
Photo 4 – Damage of multilayer element
